National Standards for Physical Inspection of Real Estate

Why Change

The Good, The Bad, and The Ugly

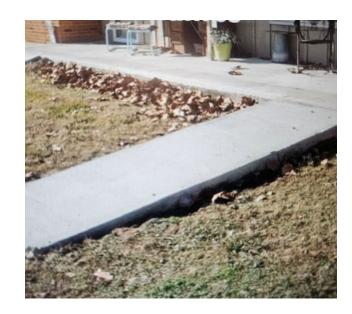
Handrail Ramps NOTE:

Handicap Ramp:

- The ramp raises 6 inches or runs 6 feet.
- Need Handrails on both sides
 - Installed 24 42 inches
 - Full length of the ramp
 - Able to grip the handrail
 - Low Pass

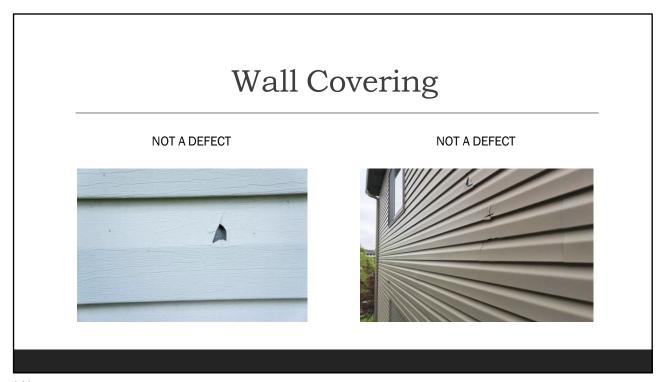
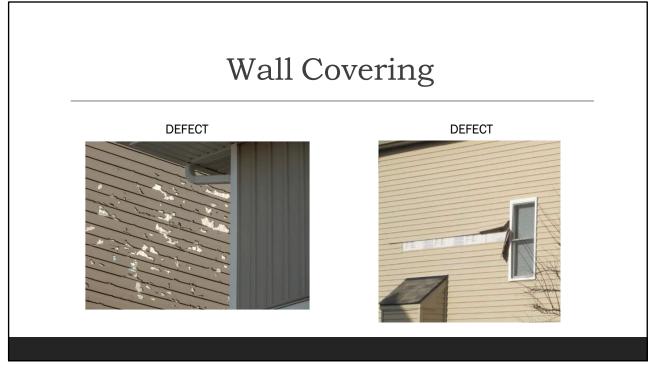
Wall Covering (Failed)

- >1 sq ft of missing material
- Any size hole penetrating the interior
- •Covering is not "functionally adequate."
- ■10 sq ft of peeling paint on a single wall (Post-1978 building)
- 30-Day Repair

Any size hole that penetrates the wall is a defect.
